# Manhole Inspection Summary

Manhole # S13S\_\_005MH

**Location** Address: **2907 Benson Ave**

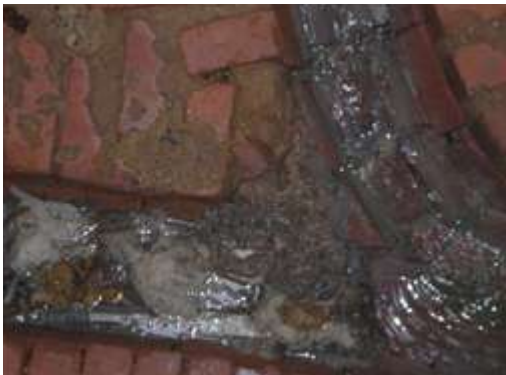
Defect 6

Condition: ☐ Sound ☐ Cracked ☐ Root Intrusion ☐ Deteriorated ☐ Leaks ☒ **Debris**

debris in channel

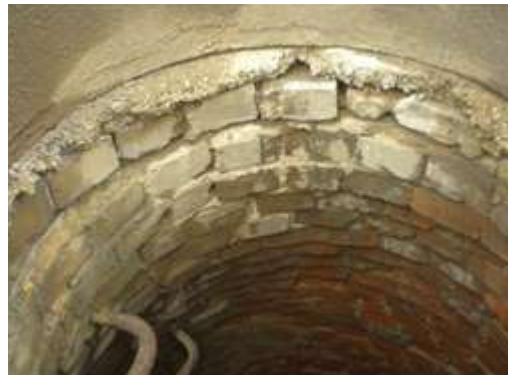
Defect 5

Condition: ☐ Sound ☐ Cracked ☐ Root Intrusion ☒ **Loose Brick** ☐ Deteriorated

Infiltration: ☐ None ☐ Joint ☐ Cracks ☐ Mortar ☐ Roots ☒ **Wall**

loose bricks chimney frame infiltration

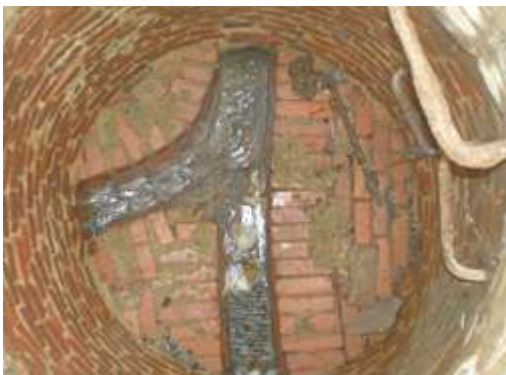
Defect 4

corroded rungs

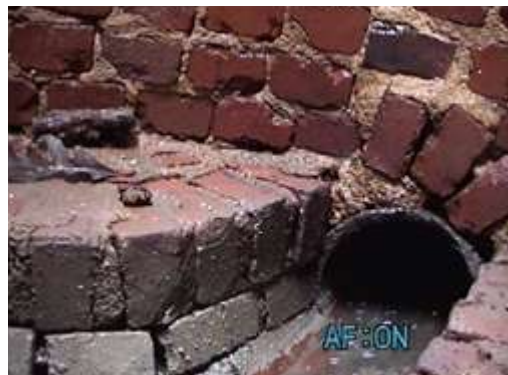
Defect 3

Condition: ☐ Sound ☐ Cracked ☐ Root Intrusion ☒ **Loose Brick** ☐ Deteriorated

missing mortar in barrel
